Renourishment of a Flood-Tidal Delta Adjacent Beach, Tauranga Harbour, New Zealand

W.P. de Lange and T.R. Healy

Department of Earth Sciences
University of Waikato
Hamilton, New Zealand

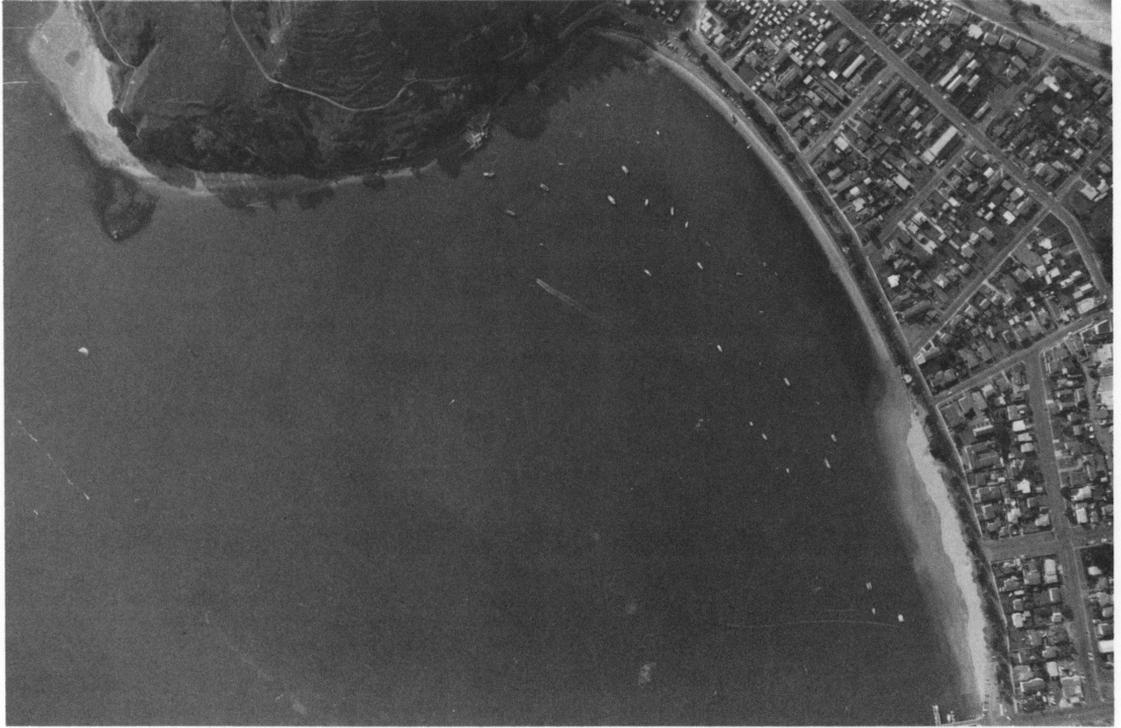
Figure 2. Aerial view of Pilot Bay Beach following renourishment (August 1984).

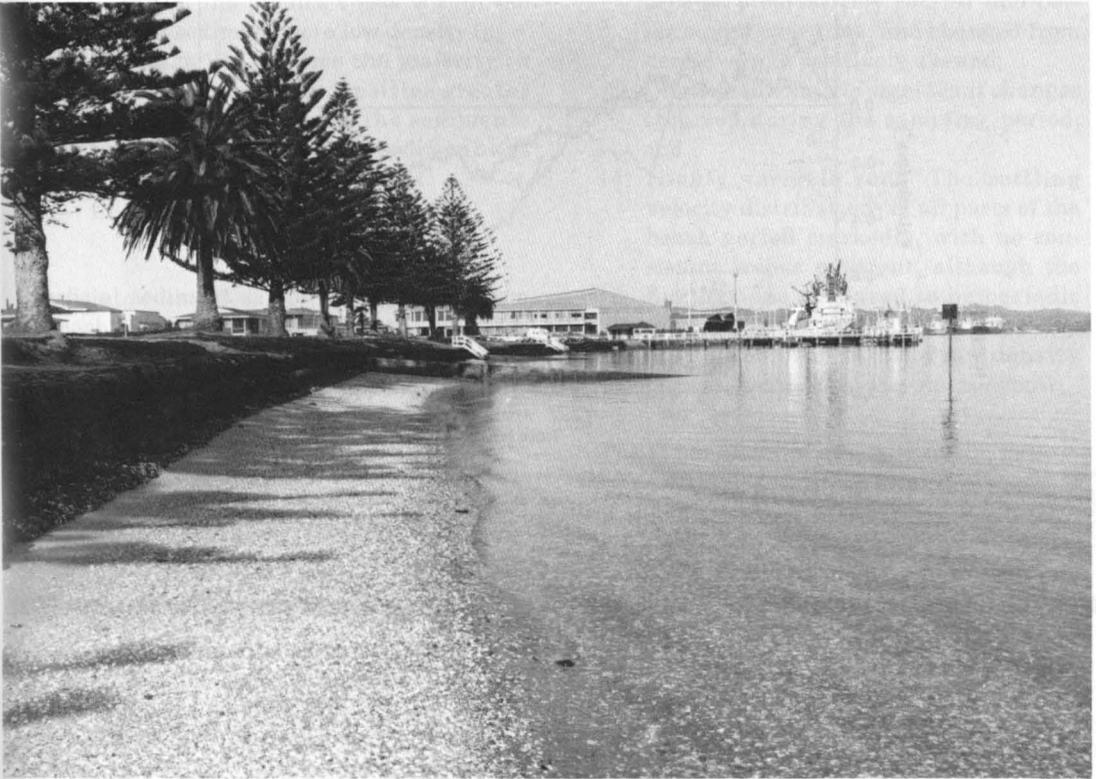
Figure 4. Pilot Bay Beach prior to renourishment (December 1983), in the vicinity of Salisbury Wharf.

Pilot Bay Beach has been observed to be eroding, particularly at the southeastern end, since the mid-1950's, and eventually, in the mid-1970's, a rock-filled gabion basket sea wall was constructed to protect the adjacent road and coastal reserve (DE LANGE, 1988). This sea wall prevented further landward erosion, but continued loss of sand from the beach prompted the construction of a series of small wooden groynes at the Salisbury Wharf, or southeastern, end of the beach. These were ineffectual for preventing further erosion, and by June 1983 the beach consisted of a narrow strip of shell and pebble rich sand at the southeastern end of the beach, most of which lay entirely below mean high water (Figure 4), with a slightly
