**COASTAL PHOTOGRAPH BY NETHERLANDS TOURIST  
OFFICE**

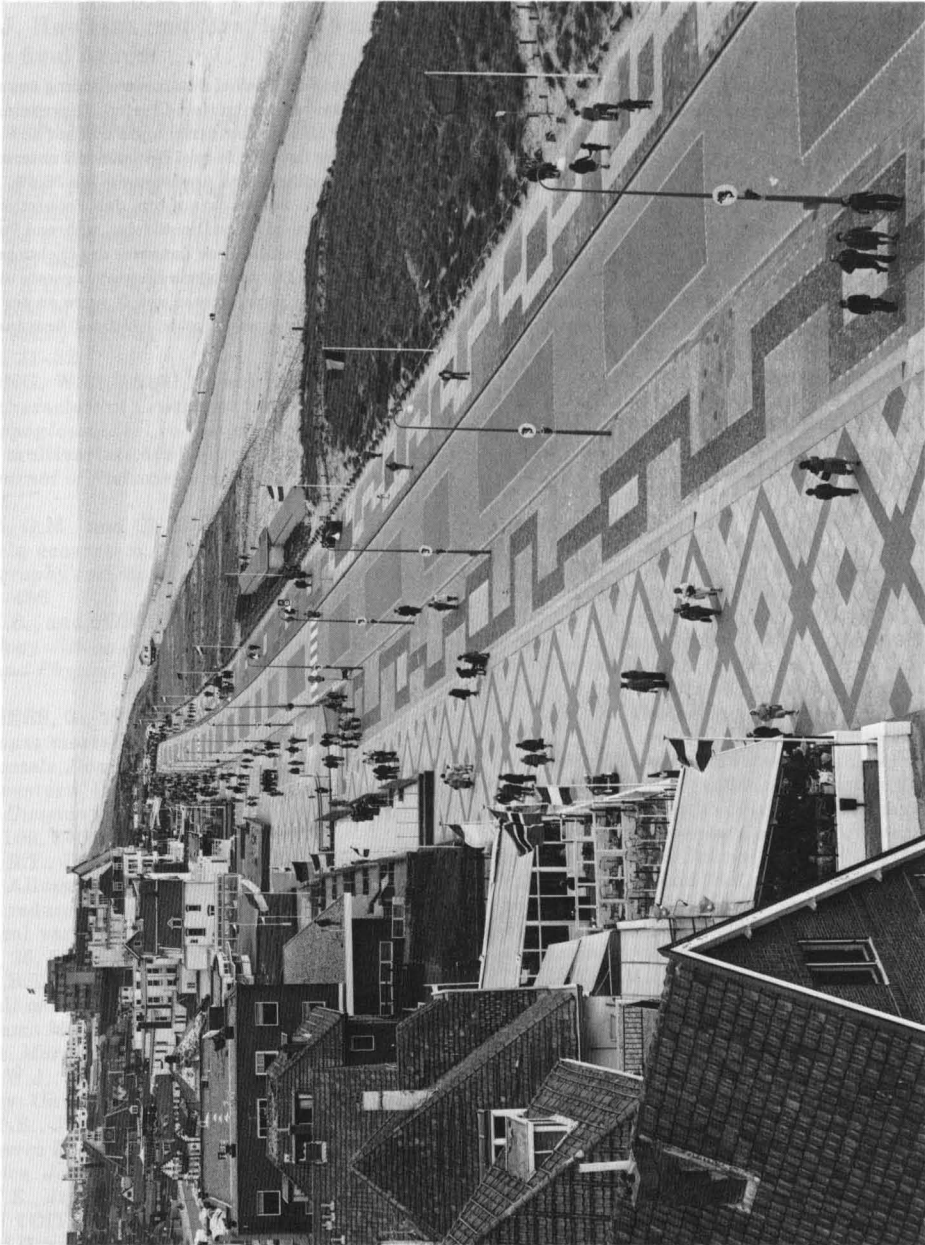
**PHOTO 147.** A low tide view of the North Sea beach at Noordwijk, The Netherlands, looking south. A strong NW wind is blowing. Original 3-bar foreshore topography is levelled by heavy surf. Coastline stabilized since ca. 1850. Note recently replanted erosional gap in foreshore. Foredune flattened to offer a room-with-a-view. (Caption: Bert van der Valk, Institute of Earth Sciences, Free University, 1007 MC Amsterdam, The Netherlands).
