Analysis of Cliff Retreat and Shoreline Erosion: Thompson Island, Massachusetts, U.S.A.

JONES, R.J.; CAMERON, B., and FISHER, J.J., 1992. Analysis of cliff retreat and shoreline erosion: Thompson Island, Massachusetts, U.S.A. *Journal of Coastal Research*, 9(1), 87-96. Fort Lauderdale (Florida). ISSN 0749-0208.

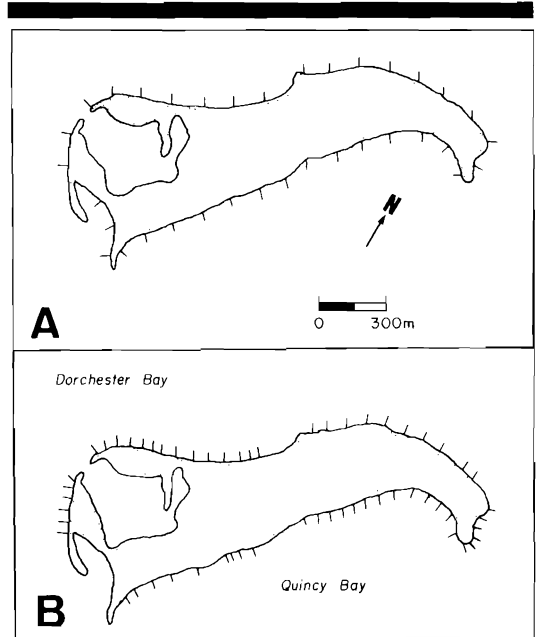
Figure 2. Thompson Island. Location of the control stations used for photogrammetric analysis (A). Location of the corresponding sediment and shear strength sampling stations (B).

Sediment samples were collected from each of the fifty-five stations along the exposed cliffs around the perimeter of the island (Figure 2b). Figures 3 and 4 illustrate some of the compositional variation found along the island perimeter cliffs. More than one sample was collected from cliff faces at locations where a visual difference in either sediment size or stratification was observed. Shoreline areas with cliffs less than about 1.65 m in height or where erosion control structures were present were not sampled (Figure 2b).

The shear strengths of the materials forming the slopes at the fifty-five sediment sampling stations (Figure 2b) were measured with a portable shear vane meter. This instrument operates on the same principle as the laboratory vane apparatus. Although it provides only an approximation to the shear strengths of the materials tested (HEAD, 1982), it does give an acceptable *in situ* estimate.

The measurements were taken by placing the portable shear vane meter on the slope adjacent to and within a few centimetres of the sediment sampling stations (Figure 2b). The shear vanes on the bottom of the meter were pushed into the slope with the instrument rotated until shear failure occurred. An average of three shear strength measurements were taken at each station.

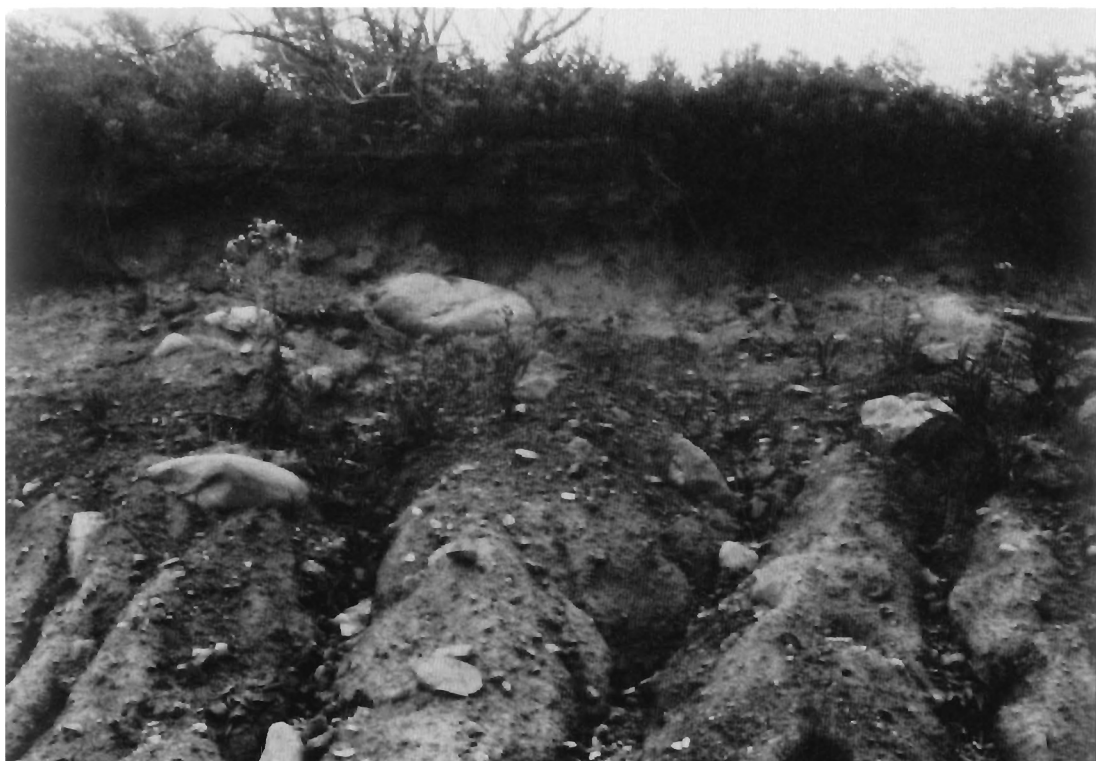
Figure 3. Photograph of typical marine cliff exposure of bouldery muddy sand from the northwest quadrant.

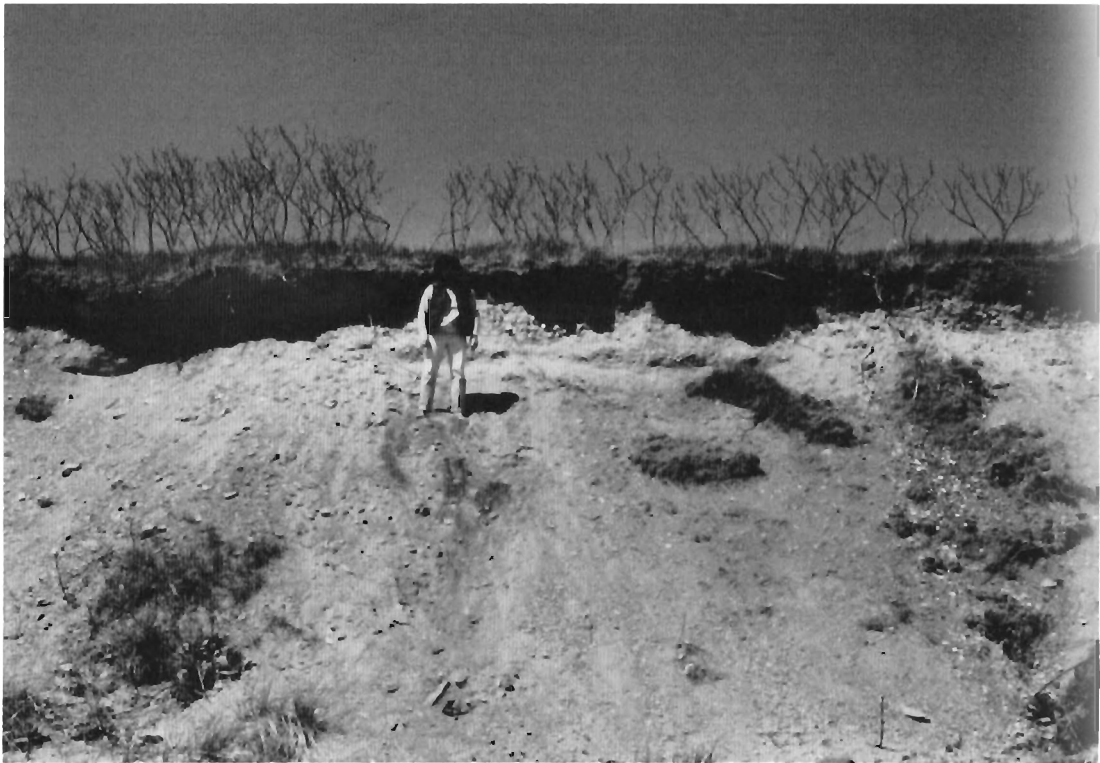
Figure 4. Photograph of typical marine cliff exposure of slightly gravelly muddy sand from the southwest quadrant.

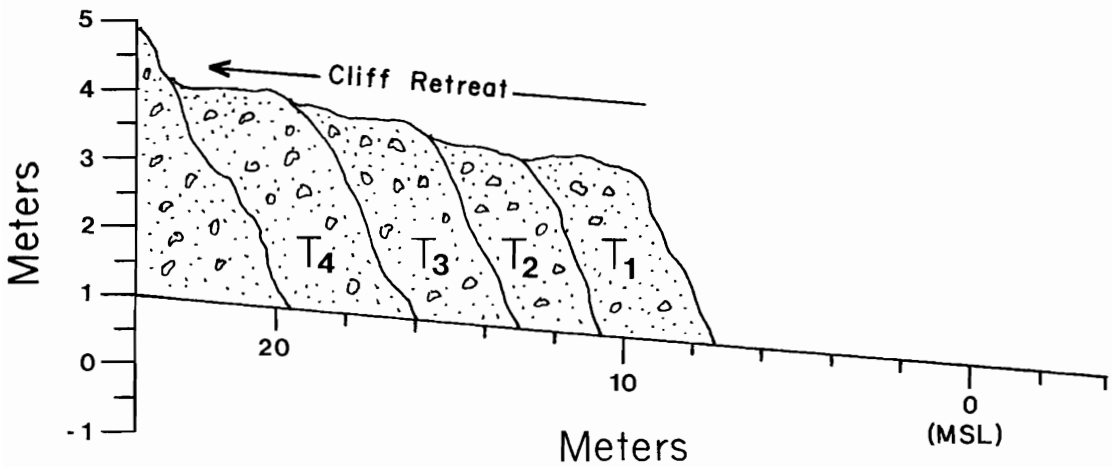
Figure 7. Idealized cross section perpendicular to the shoreline of an eroding sea cliff to illustrate how successive erosive events from time 1 to time 4 can create an area of erosional loss that resembles a parallelogram. The cross-sectional areas of beach erosion loss can also be approximated by the geometric shape of a parallelogram (McCORMICK, 1973).
