COASTAL PHOTOGRAPH BY ANDREW MORANG

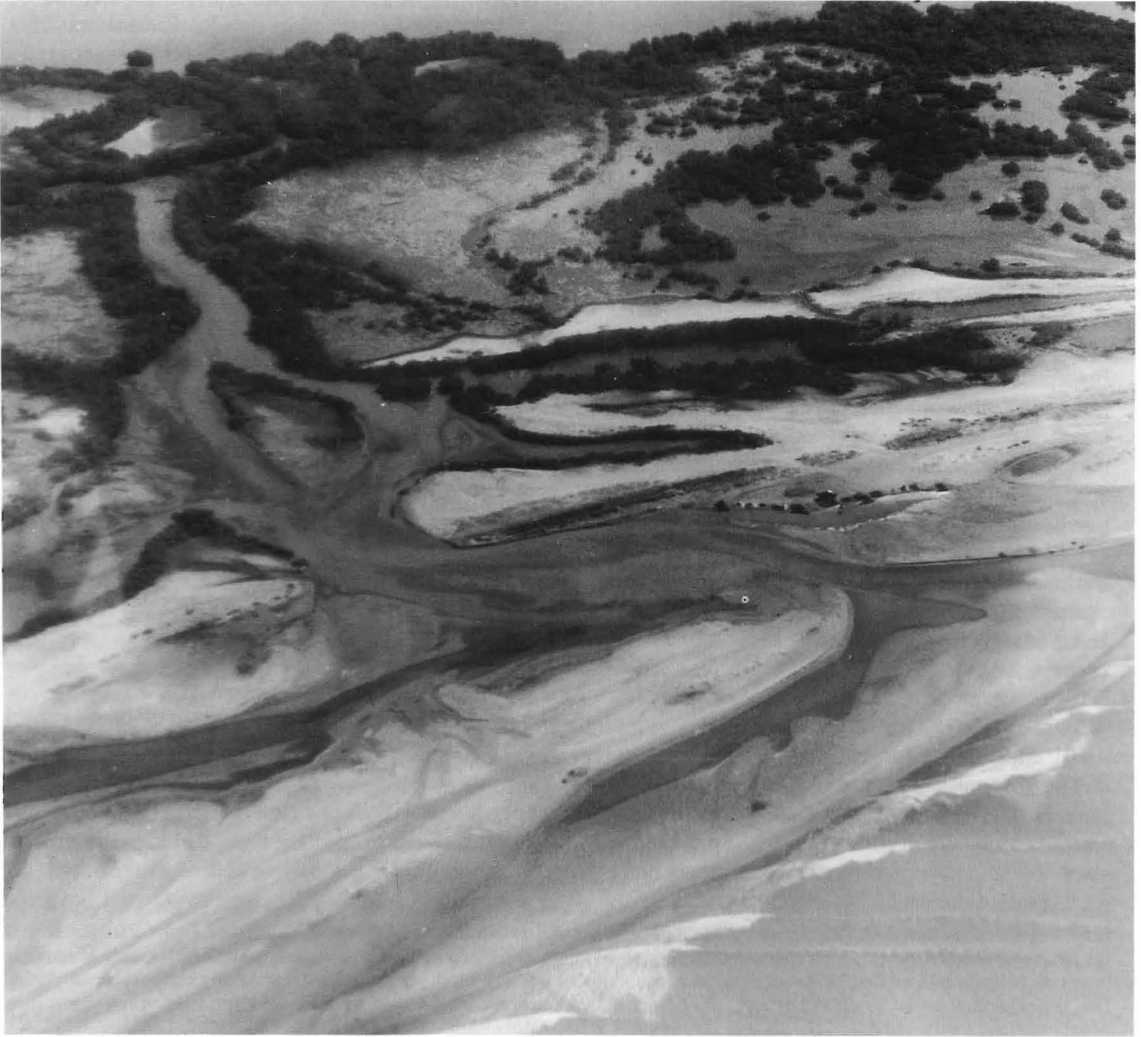
PHOTO 55. Barrier beach west of Cienaga de la Tesa, Colombia. This is part of the barrier beach complex which separates a large coastal lagoon (seen in the upper left) from the Caribbean Sea. Part of the barrier is well established and is anchored with shrubs and trees, while the seaward face is low and subject to rapid change by wind and waves. The steep approach angle of the waves has produced westward-flowing longshore currents (left to right in the picture), resulting in the westward growth of the prominent sand spit. Note that a drainage outlet from the pond also swings to the west, in response to older sand spits which are not beach ridges. The mouth of the drainage outlet is almost blocked by the new barrier spit, and a breakthrough is likely to occur, especially after a rainstorm when the lagoon is full. View looking south, taken from about 1,500 feet altitude. Distance from surf to lagoon is about one kilometer. Date: February, 1981. (Photograph by Andrew Morang, U.S. Army Engineer Waterways Experiment Station, Coastal Engineering Research Center, Vicksburg, MS 39180.)
