**COASTAL PHOTOGRAPH BY DAVID M. BUSH,
E. ROBERT THIELER, AND ORRIN H. PILKEY**

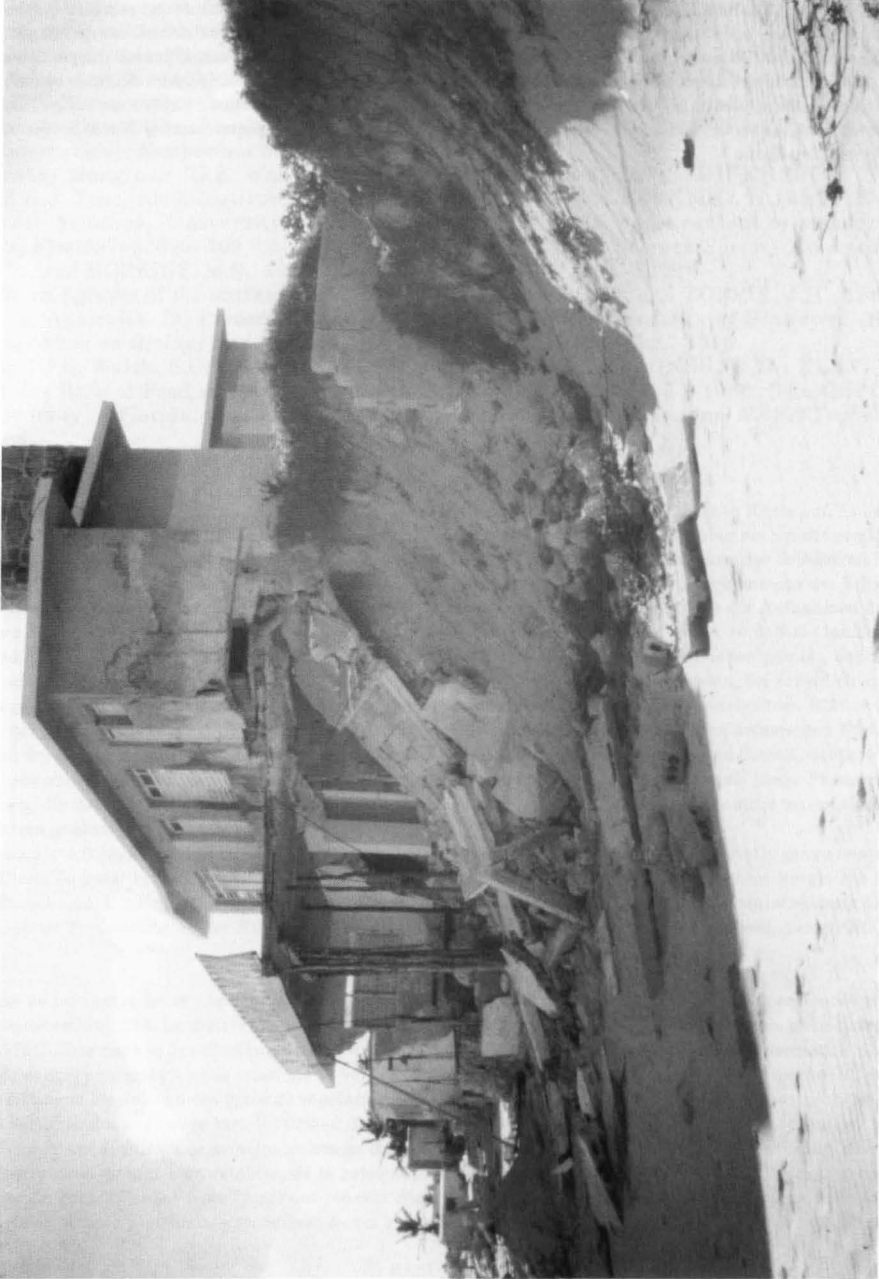
PHOTO 115. Dunes and buildings at this location eroded at about the same rate in Hurricane Gilbert, September 1988. This photo from the north coast of the Yucatan peninsula, Mexico shows the natural dune line essentially lined up with surviving sections of houses. (Photo: David M. Bush, E. Robert Thieler, and Orrin H. Pilkey, Program for the Study of Developed Shorelines, Department of Geology, Duke University, Durham NC 27708).
