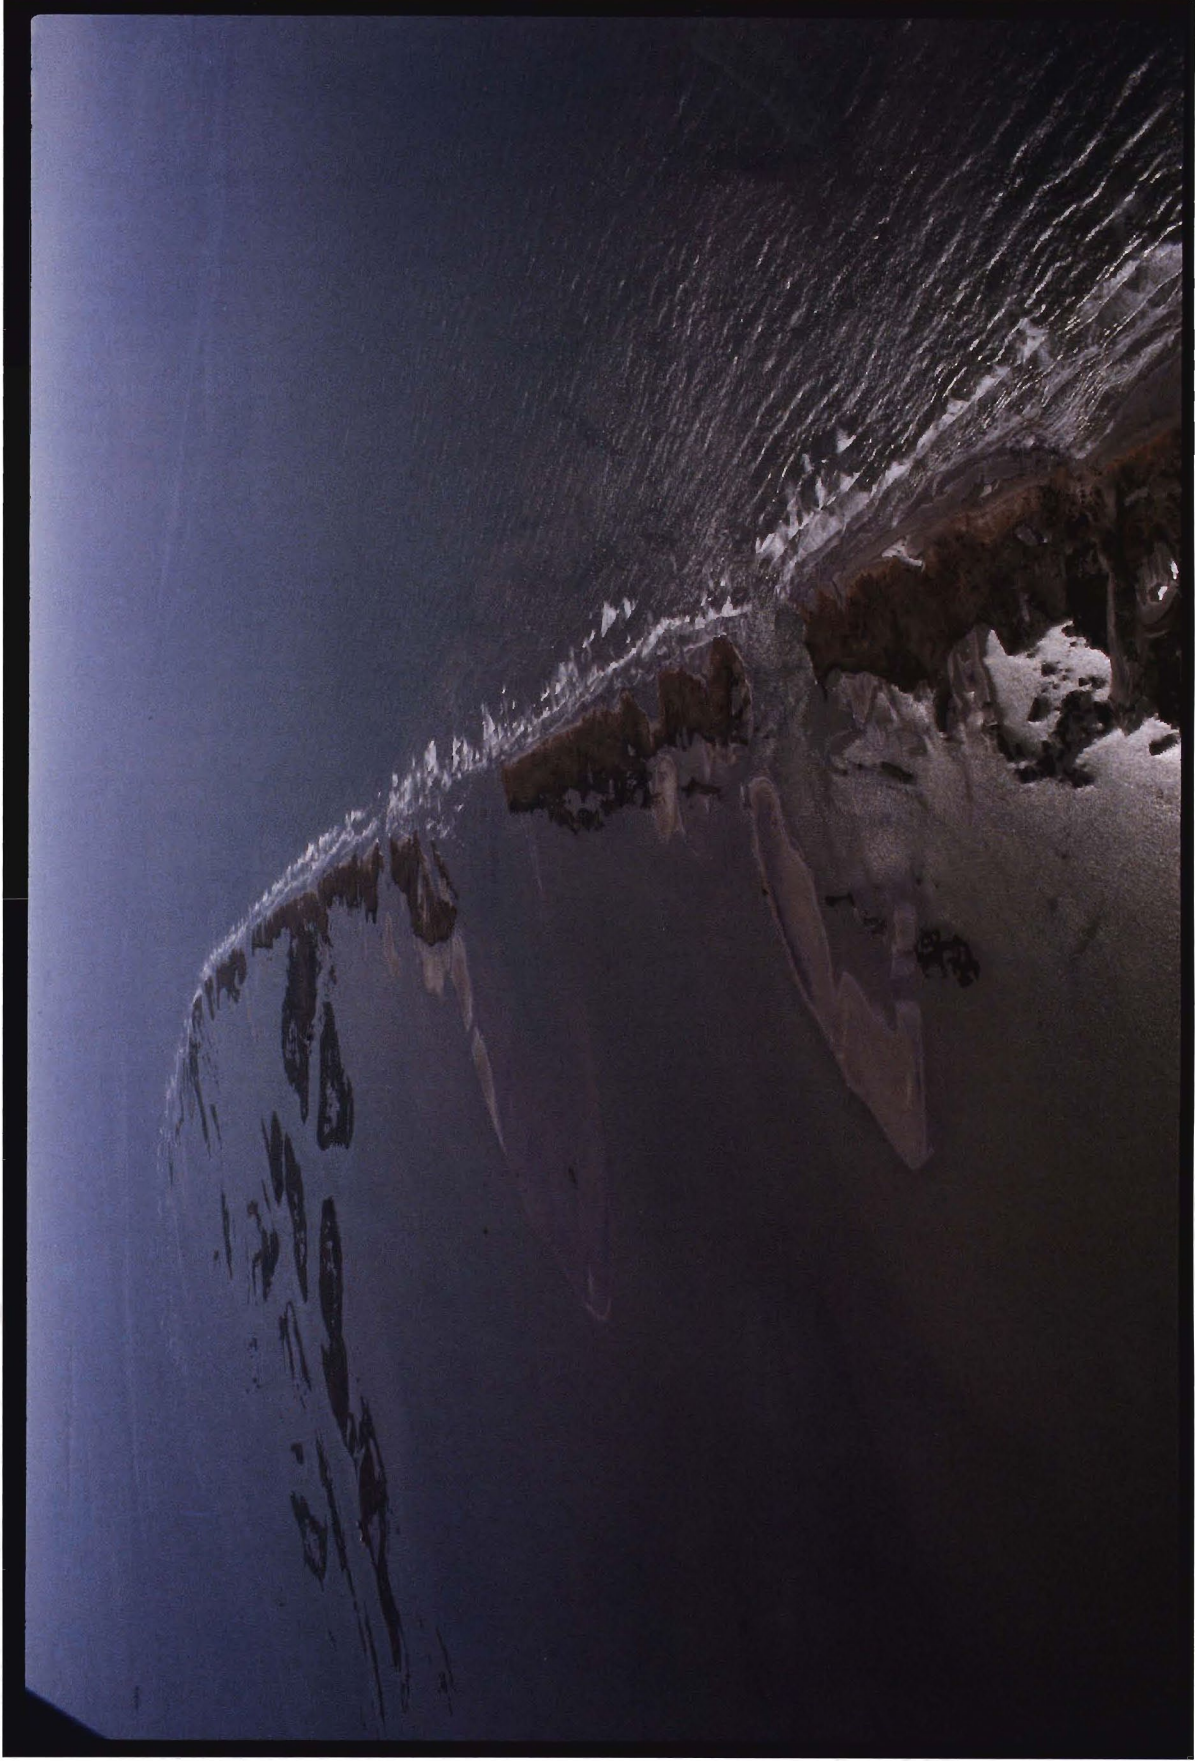
Oblique photograph looking east along a portion of the Isles Dernieres, Louisiana. This barrier island chain is experiencing erosion at rates exceeding  $20 \text{ m yr}^{-1}$  and has been projected to disappear within the next few decades. Elevations rarely exceed 2 m above sea level and this particular photograph demonstrates exposure of the mud core after complete removal of the sand veneer during Hurricane Andrew. (Photograph taken September 1992 by G. W. Stone, LSU).
